TECHNICAL NOTES

The following information is for reference & guidance only.

ASSORTED MANUFACTURERS

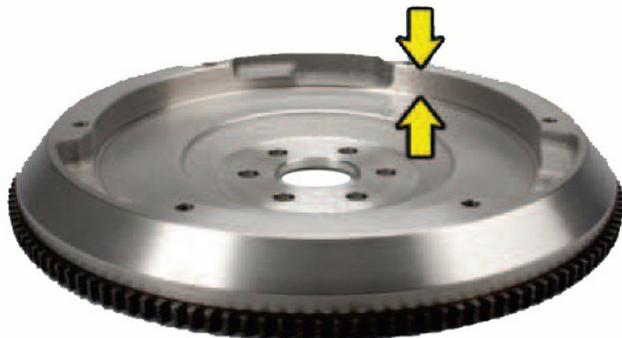
Earlier 19mm Deep Flywheel

By following the engine or chassis number guidelines you should be able to choose the correct clutch but where possible get a measurement of the flywheel depth as even some of the earlier vehicles have been retro-fitted with the newer flywheel.

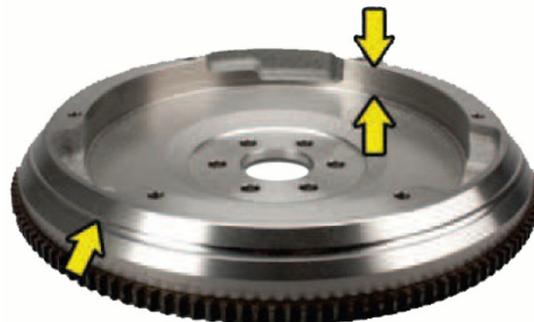
Later 21mm Deep Flywheel

Note: Visible rim machined into OE versions of 21mm deep Flywheel
