Nationals 3 Year Warranty Statement

Damaged Concentric Slave Cylinders (CSC)

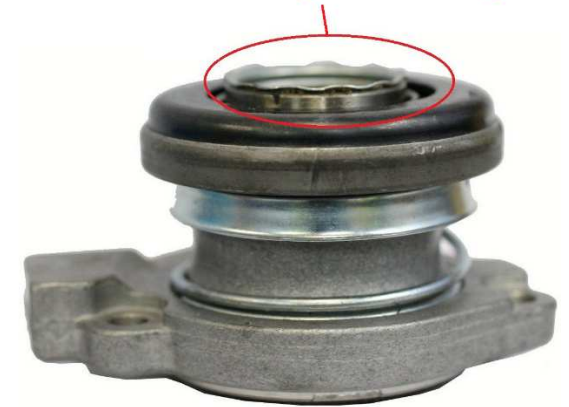
Overstroking resulting in a damaged end cap

Over stroking the unit

Don't pump the pedal rapidly during bleeding. This forces the roller bearing beyond its designed stroke length and the main seal located behind the bearing become damaged from fouling the guide tube metal end cap (refer to image)

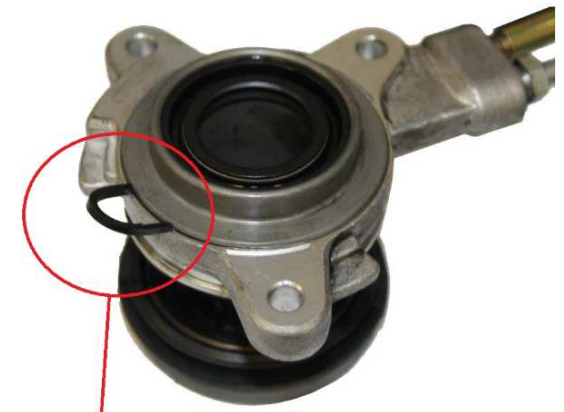
The unit was not bolted down evenly, resulting in the backplate moving and exposing the inner seal.

Correct gearbox seating

On most CSC's, the gearbox holds the back plate in place after fitment. If the CSC has not been seated squarely, then hydraulic pressure will eventually force the back plate out of position (refer to image)
